# Manhole Inspection Summary

Manhole # S41II\_039MH

Insp Date: **6/9/09 9:19 AM**

**Location** Address: **1541 CAROLINE ST**

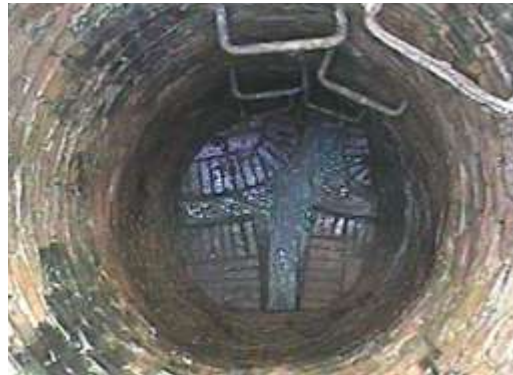
Top View

Condition: ☐ Sound ☒ **Cracked** ☐ Root Intrusion ☐ Loose Brick ☐ Deteriorated

Count: **8** Missing: **1** ☒ **Corroded**
